PROCESS WATER TREATMENT

Coal Burning Power Generating Plant Removes Turbine Oil Sheen From Process Water Discharge.

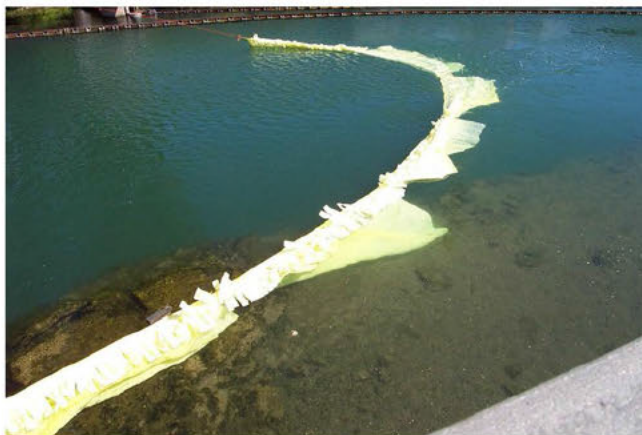
The cooling water passed through an oil water separator before exiting to the lake. While removing the majority of the contaminating turbine oils, the separator could not effectively remove the sheen. The very high volumes of process water being used created a current at the plant outlet in excess of 5 knots, making the sheen very difficult to capture. The 8" sock net booms being employed were ineffective. The contractor replaced the sock booms with a MYCELX Terraguard boom and the sheen stopped immediately.

Once it was verified that the only hydrocarbons being released was the visible surface sheen, the Terraguard booms were replaced with MYCELX Versimat booms. The booms are replaced every 6 weeks, and there has not been a single further incident of sheen escaping to the lake.
